A Practical Engineering Approach to Improving the Reliability of Blast Furnace Tuyeres

Made predominantly of cast copper, with water-cooled channels, the tuyere is the device that allows heated air to be blown into the combustion raceway of the blast furnace. Exposed to a harsh and turbulent operating environment, the tuyere region is dynamic and complex, containing combustion gases, molten oxides (slags), molten iron, coke, pulverized coal, char and temperatures frequently exceeding 4,000°F (2,204°C). Although recognized as a key component, an indestructible tuyere has yet to be developed. Poor tuyere reliability is not a recent phenomenon. Despite being the dominant ironmaking route, and after several centuries of development, blast furnaces are still prone to suffering tuyere failures.¹ A tuyere failure introduces a state of affairs that all operators try to avoid, typically furnace instability, increased costs and fuel rate, lost productivity, and increased safety and environmental exposure.

At Severstal Dearborn, an employee involvement program team was assembled to focus on improving the reliability of blast furnace tuyeres. A practical engineering approach was adopted for

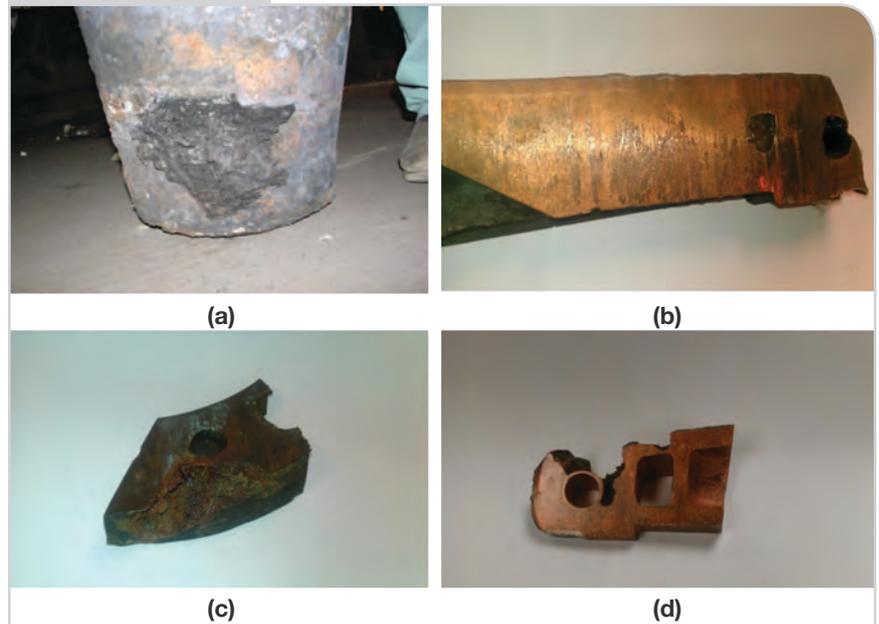
Figure 5

Two manufacturing flaws, seriously affecting reliability, were uncovered upon examination of failed tuyere sections. The first issue found occurred during an effort to secure a domestic tuyere supplier. A design was chosen that included a cast-in copper pipe that created the nose loop. A copper pipe is formed to the shape of the nose loop, cleaned and set into position in the core box, along with the sand cores that create the body passages. Molten copper is then poured around the preformed nose loop pipe and sand cores, forming the tuyere. The benefit in such a design is that the nose loop can be preformed into relatively smooth shapes, helping to prevent water flow eddies. Shortly after installation, tuyeres featuring the cast-in copper nose loop pipe began to fail. Failures were commonly seen after only a few days or weeks of service. The nose copper was burnt away to the point where the copper pipe became exposed to the furnace (Figure 5). In extreme cases, the tuyere nose tip was missing 1.5 inches of copper. Upon removal and inspection, the casting was found lacking a consistent and complete metallurgical bond to the cast-in copper pipe. Sections taken bisecting the nose loop allowed the pipe to simply fall from the casting. A black, powdery substance was

Failures and casting defects: hot metal attack due to iron dripping on tuyere surface, damage above low water velocity area (a); voids in casting, manufacturing defect (cast-in pipe); nose erosion (b); hot metal attack, manufacturing defect (cast-in pipe) (c); and manufacturing defect (cast-in pipe), hot metal attack penetrating hard surface coating (d).

present between the pipe and casting. Even a minute gap between the casting and copper pipe nose loop creates a barrier to heat transfer.²² When insufficient heat is removed from the casting, the copper melts away. Exposed to the raceway, the thin-walled pipe (0.125-inch wall thickness) is not robust enough to survive inside a blast furnace.

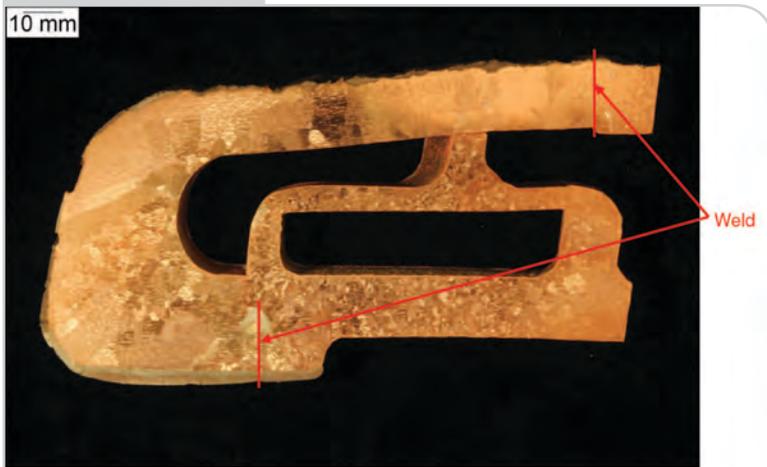
Figure 6

Welds and heat-affected zones in spiral tuyere.

A later, more insidious manufacturing flaw was discovered after polishing and etching a section from a failed spiral nose tuyere. Revealed were weld joints created by using dissimilar filler metal and heat-affected zones on the outer tuyere surface (Figure 5). This design, characterized by its three-piece construction, is detailed in the Failure Concentration Mapping section, below.

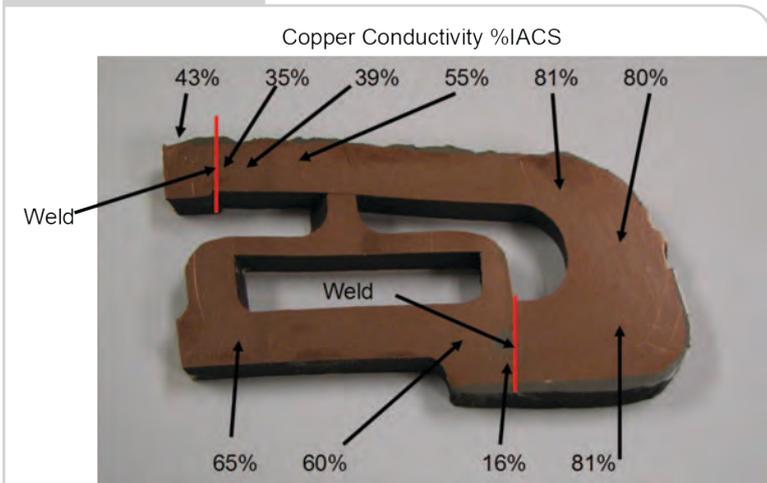
Figure 7

Spiral tuyere electrical conductivity study.

Electrical Conductivity Testing — To aid in the failure analysis of the second manufacturing flaw listed above, electrical conductivity tests were performed. Focusing on the common failure point, conductivity of the casting was measured across the weld line (Figure 12). According to the Wiedemann-Frantz law, electrical conductivity is proportional to thermal conductivity.³³ Electrical conductivities as low as 16% International Annealed Copper Standard (IACS) were observed. At the outer circumferential weld, where failures were most common, the thermal conductivity of the weld zone was only about one-third of the thermal conductivity of pure copper. This forms a weak point where the casting is not sufficiently cooled and simply melts away to eventual failure. Electrical conductivity specifications were increased, and more rigorous testing was required of tuyere manufacturers as Severstal realized the significance this parameter plays in tuyere performance.

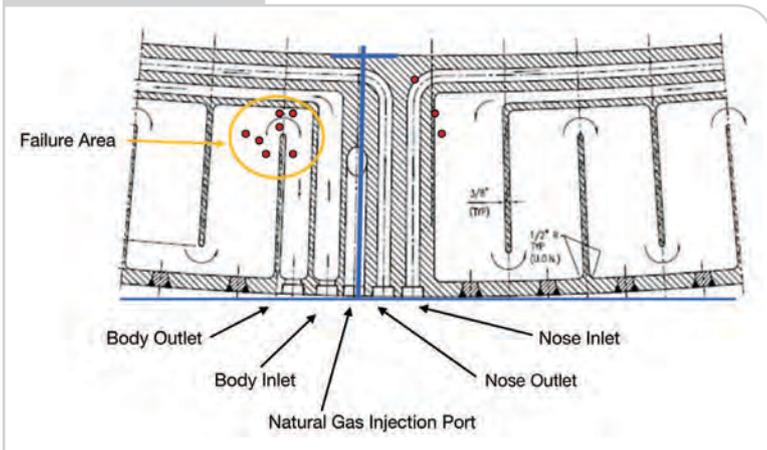
Figure 8

Original tuyere failure concentration map.

Failure Concentration Mapping — As part of the standard failed tuyere analysis process, each point of failure was plotted on a drawing that illustrated water passages within the tuyere. In time, a concentration map was developed, indicating a common failure point in the original tuyere design. Although the failure rate varied with changing operating parameters, the common failure point and apparent mechanism remained the same (Figure 8). The

body passage outlet, where the cooling water reached its maximum temperature and an abrupt change in cross-sectional water passage area occurs, lay directly below the common failure point. A practical observation, later confirmed by computer flow modeling, was made that indicated possible low water velocity and flow eddies in this area. Increasing water velocity will help prevent tuyere burnout, and efforts were made to improve water velocity in the common failure location.^{36,37}

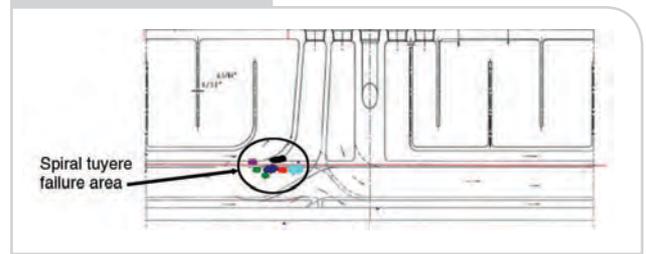
Figure 9

Failure mapping continued as new designs were trialed. A second failure concentration point was noted in a third-generation design. Circumferential water-cooling passages across the tuyere nose characterized this third-generation “spiral” tuyere. It was assumed that greatly increased water velocity in the original common failure location, as noted earlier, would prevent reliability issues. In operation, this design performed worse than the original lower water velocity tuyere. Spiral tuyeres at Severstal are manufactured from three pieces of copper: a nose casting, body casting and an internal piece that creates the spiral flow. Two circumferential welds, attaching the body to the nose casting, characterize the spiral-type tuyere. Severstal Dearborn also employs a natural gas port in the tuyere, which forced the outer circumferential weld close to the tuyere nose. The failure concentration map indicated failure points on the outer circumferential weld line. Incidentally, the failure pattern was almost identical to the burns Amber Dalley reported in 2001.³⁴

Failure concentration map, spiral nose design.

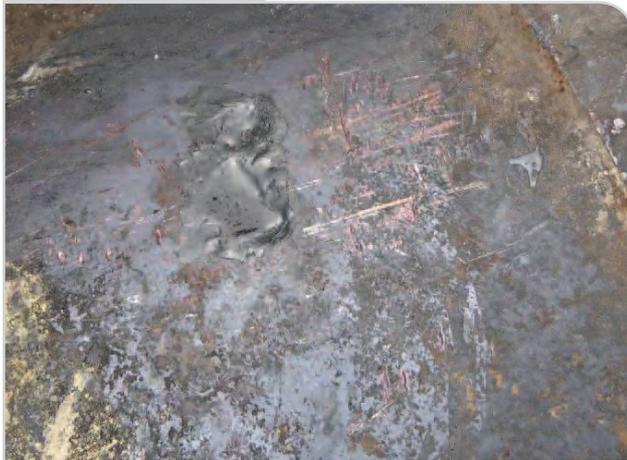
Figure 14

Bare copper tuyere completely penetrated with iron after pour test.

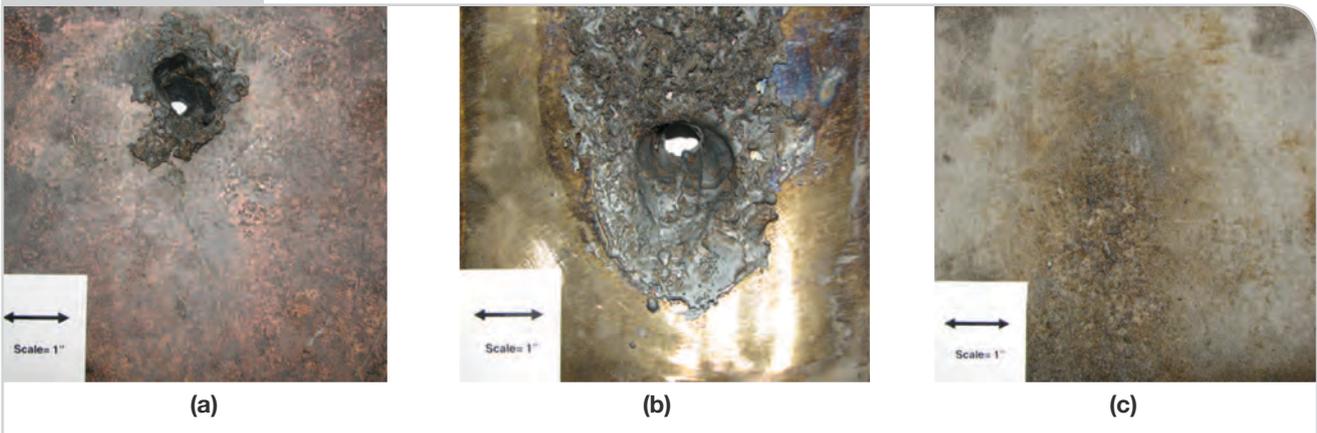
Figure 15

Photographs of copper plates after second pour test.

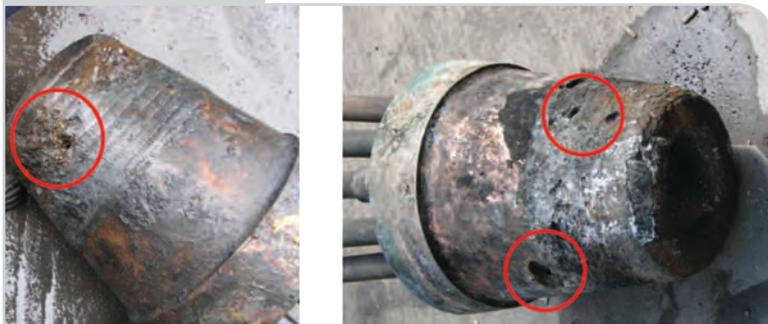
Figure 18

Typical bullet-hole burns (circled) in failed tuyeres.

period, with bullet-hole hot metal burns common. The authors propose that nut coke on the furnace wall somehow changes the permeability above the tuyeres, causing hot metal to occasionally flood the top of the tuyere, resulting in a bullet-hole-type burn. Examples of bullet-hole burns are pictured in Figure 18. This strategy was abandoned when the excess nut coke was consumed.

Another operating path sought to minimize “short circuits” and “channeling” (events of excessive gas flow on the walls resulting excursions of high top pressure) by increasing the ore loading at the wall, while simultaneously operating with high oxygen levels (targeted blast oxygen up to 34%) to boost productivity. Figure 17a illustrates the high wall ore loading, with Figure 19 showing a two-year raceway adiabatic flame temperature (RAFT) graph. While using this practice, the blast furnace experienced high flame temperatures, (speculated) low cohesive zone position and increased hot metal production at the wall — all variables that increase a tuyeres susceptibility to failure. This operating scheme culminated in an extended outage to replace three tipped tuyeres. The high flame temperature practice was abandoned after repairs were made replacing tipped tuyeres. The target RAFT temperature was reduced 400°F, from 4,100°F, and the ore-to-coke ratio at the wall was increased to 55% from 30% (Figure 17c).

This change resulted in fewer bullet-hole-type hot metal burns on the tuyere tops. Ultimately, tuyere failure rates have been greatest during periods of radical burden changes.

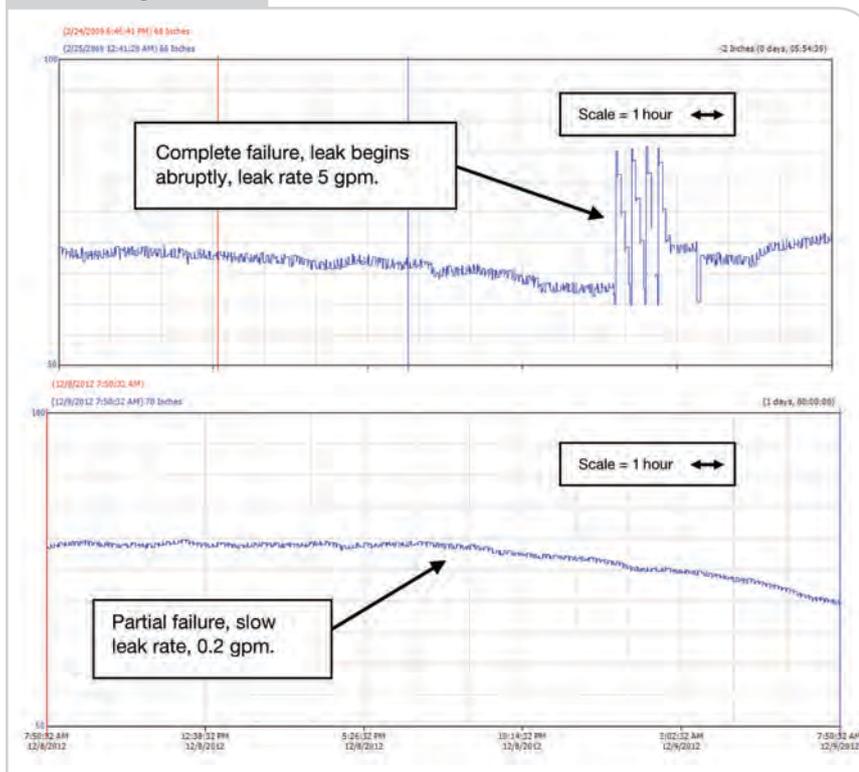
during planned maintenance outages before a failure becomes “complete.” Figure 21 shows an example of a complete failure and a “partial” failure.

Examples of tuyere failures.
