A Practical Engineering Approach to Improving the Reliability of Blast Furnace Tuyeres

Made predominantly of cast copper, with water-cooled channels, the tuyere is the device that allows heated air to be blown into the combustion raceway of the blast furnace. Exposed to a harsh and turbulent operating environment, the tuyere region is dynamic and complex, containing combustion gases, molten oxides (slags), molten iron, coke, pulverized coal, char and temperatures frequently exceeding 4,000°F (2,204°C). Although recognized as a key component, an indestructible tuyere has yet to be developed. Poor tuyere reliability is not a recent phenomenon. Despite being the dominant ironmaking route, and after several centuries of development, blast furnaces are still prone to suffering tuyere failures.¹ A tuyere failure introduces a state of affairs that all operators try to avoid, typically furnace instability, increased costs and fuel rate, lost productivity, and increased safety and environmental exposure.

At Severstal Dearborn, an employee involvement program team was assembled to focus on improving the reliability of blast furnace tuyeres. A practical engineering approach was adopted for

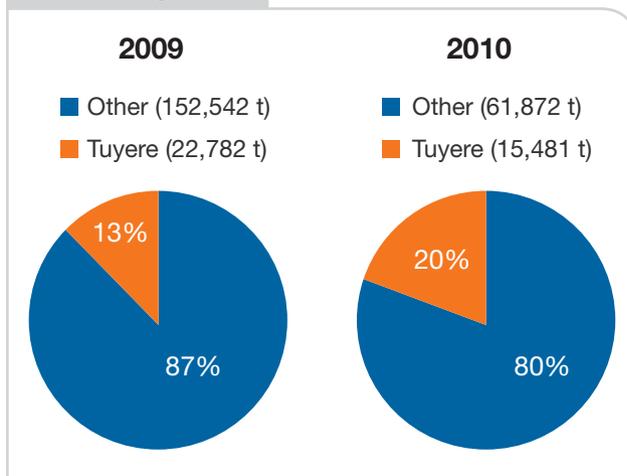
Figure 1

Production lost to tuyere failures in 2009–10; tuyere failures were the largest individual source of delays.

analysis. Early in the delay analysis process, it became apparent that poor tuyere reliability accounted for a significant fraction of total delay time. In fact, during 2009–10, tuyere failures were the largest single source of Ironmaking internal delays (Figure 1), and average tuyere life was less than 120 days. The current benchmark life of 460 days was rarely achieved. Figure 2, a tuyere life chart, illustrates poor performance and the high early failure rate.

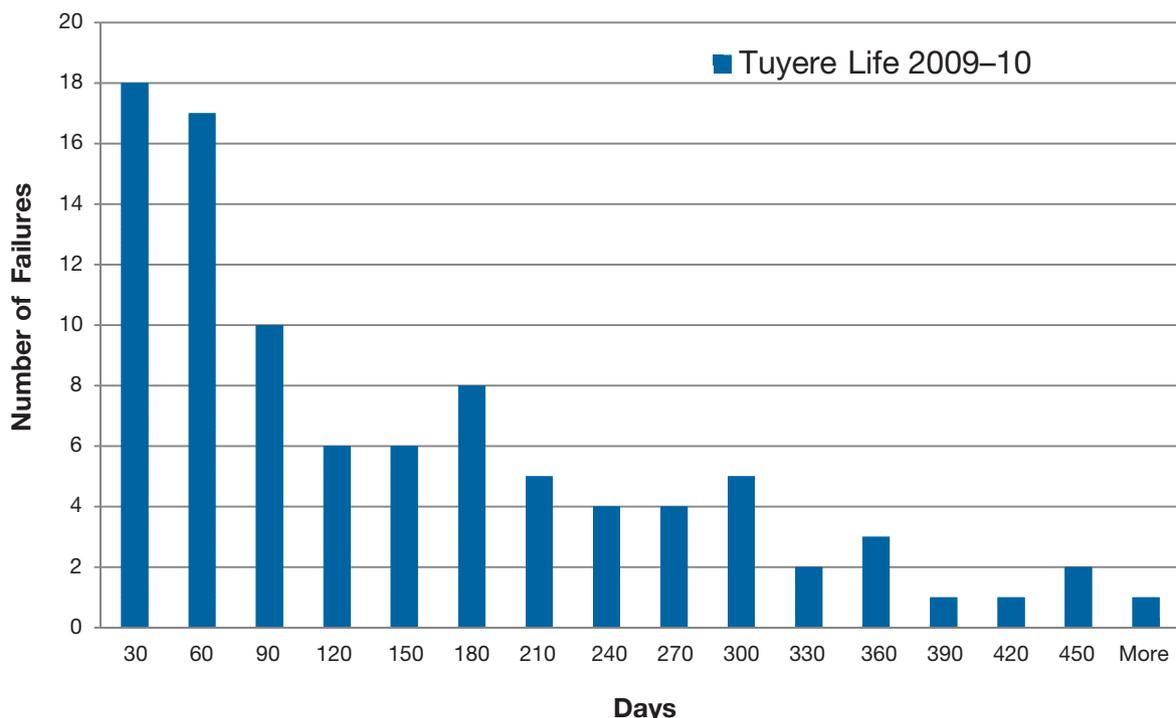
Figure 2

Tuyere life in days, 2009-10. Note the high early failure rate.

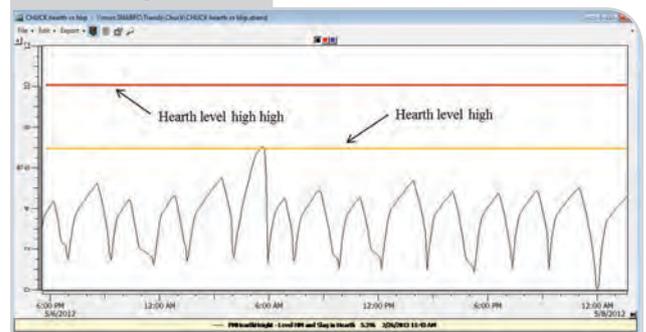
Figure 10

Data Monitoring/Analysis — Ironmakers at Severstal Dearborn are fortunate to have extensive instrumentation and monitoring capabilities available. Tuyere reliability improvements depend in part on providing operators with practical tools, helping to indicate when conditions are such that a tuyere failure may occur. Two examples are shown in Figures 9 and 10. Figure 9 is a chart in which the hearth liquid level is monitored. High liquid level in a blast furnace hearth will distort raceway gases in a manner that may increase heat load on the tuyere or promote wall working — two conditions that will decrease reliability.³⁵ A failure can also occur when high levels are taken to an extreme and liquids contact the tuyere bottom (Figure 10).

Hearth liquid level.

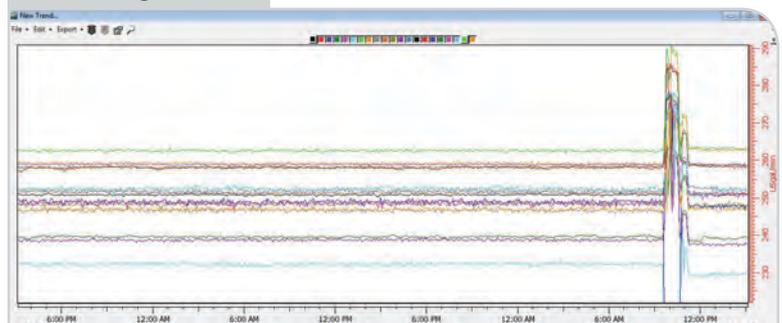
Figure 11

Tuyere water flows.

constant water flow. In the event of a catastrophic pipe break or total loss of pumping capability, pressurized mill water will flood the system as a tertiary backup. Tuyere water flows are shown in Figure 11. Additional continuous monitoring activities also include actively watching wall heat loading and gas flow.

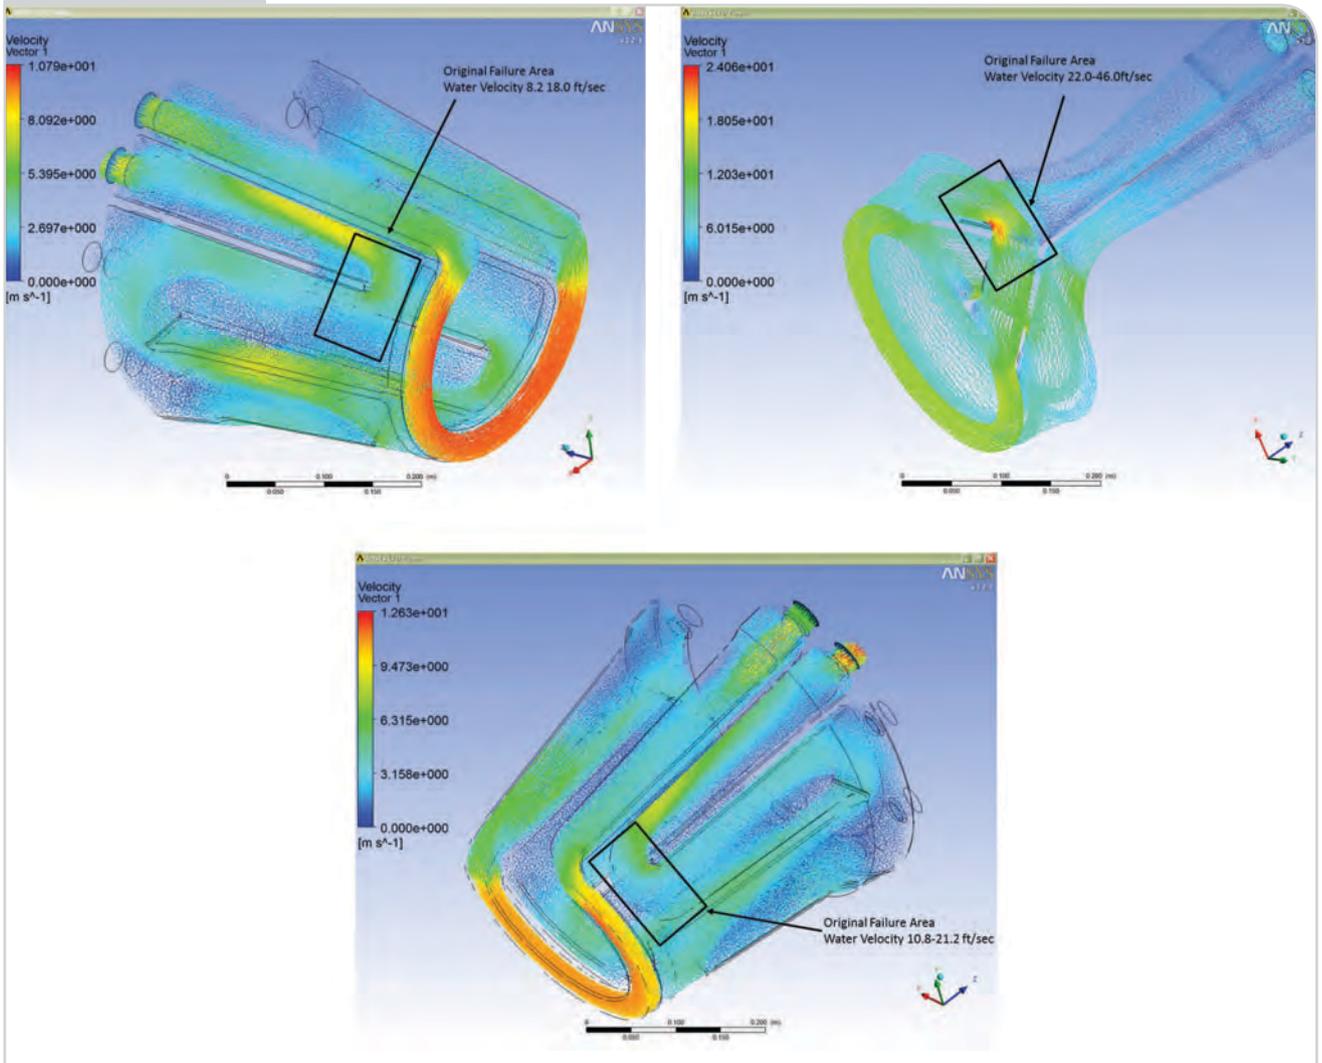
Figure 12

CFD Modeling — Concentration failure mapping indicated a common failure point in the original tuyere. This common failure point was over an area where low water velocity and flow eddies were thought to occur. Low water velocity will decrease a tuyere’s resistance to failure.^{37,38} A computational fluid dynamics (CFD) model confirmed suspicion of low water velocity and recirculation design (Figure 12a). A subsequent and ultimately unsuccessful (due to manufacturing issues) design revision was made to improve water velocity. A second CFD model confirmed the improve water velocity (Figure 12b). Figure 12c is a CFD model created as part of the review process before a new design is approved. The model indicated less recirculation and higher water velocity in the known failure area. The design in Figure 12c ultimately proved successful. Proving to be a useful evaluation tool, CFD modeling is now required before any design changes are approved.

CFD models of tuyeres.

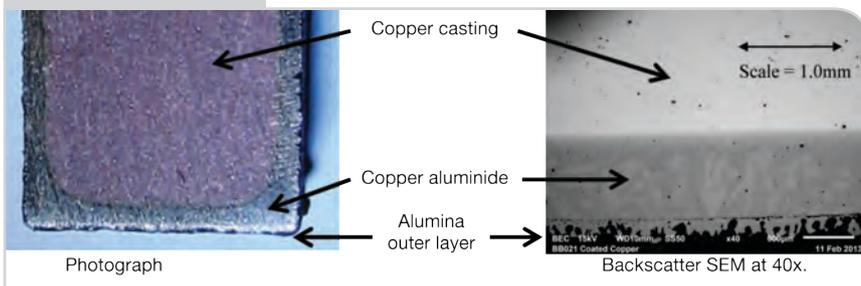
Figure 13

copper casting is placed in a sealed retort containing aluminum powder. The casting is heated and aluminum is diffused into the surface, creating a copper aluminide inner layer and an aluminum oxide outer layer.^{39,40} The various layers can be seen in Figure 13. This is not a new technology; publications from the 1910s and 1920s assert calorizing as beneficial to tuyere life.^{41,42} A Russian article goes so far as to say “...tuyere life is increased by 3–4 times...”⁴²

Photograph of a calorized copper plate cut in half.

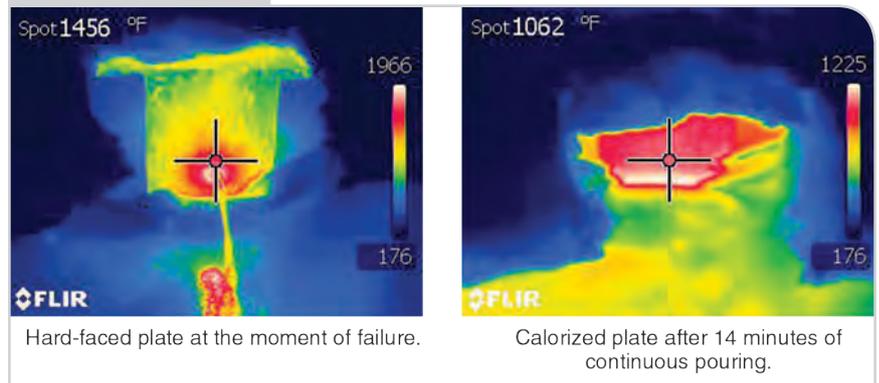
Figure 16

all the poured iron could be collected and weighed. Again, iron was poured onto the test block surface until failure by complete penetration occurred. A thermal imaging camera was positioned on the cold side of the plates to document the failure process. The bare copper (Figure 15a) and hard-faced plate (Figure 15b) burned through quickly, while the calorized plate survived undamaged (Figure 15c). Pouring on the calorized plate was stopped after the container used to hold the iron filled up. The calorized surface is an insulating, non-wettable coating that provides significant protection from hot metal contact.³⁹ Infrared video footage captured the failing plates (Figure 16).

Infrared images of second test plates.

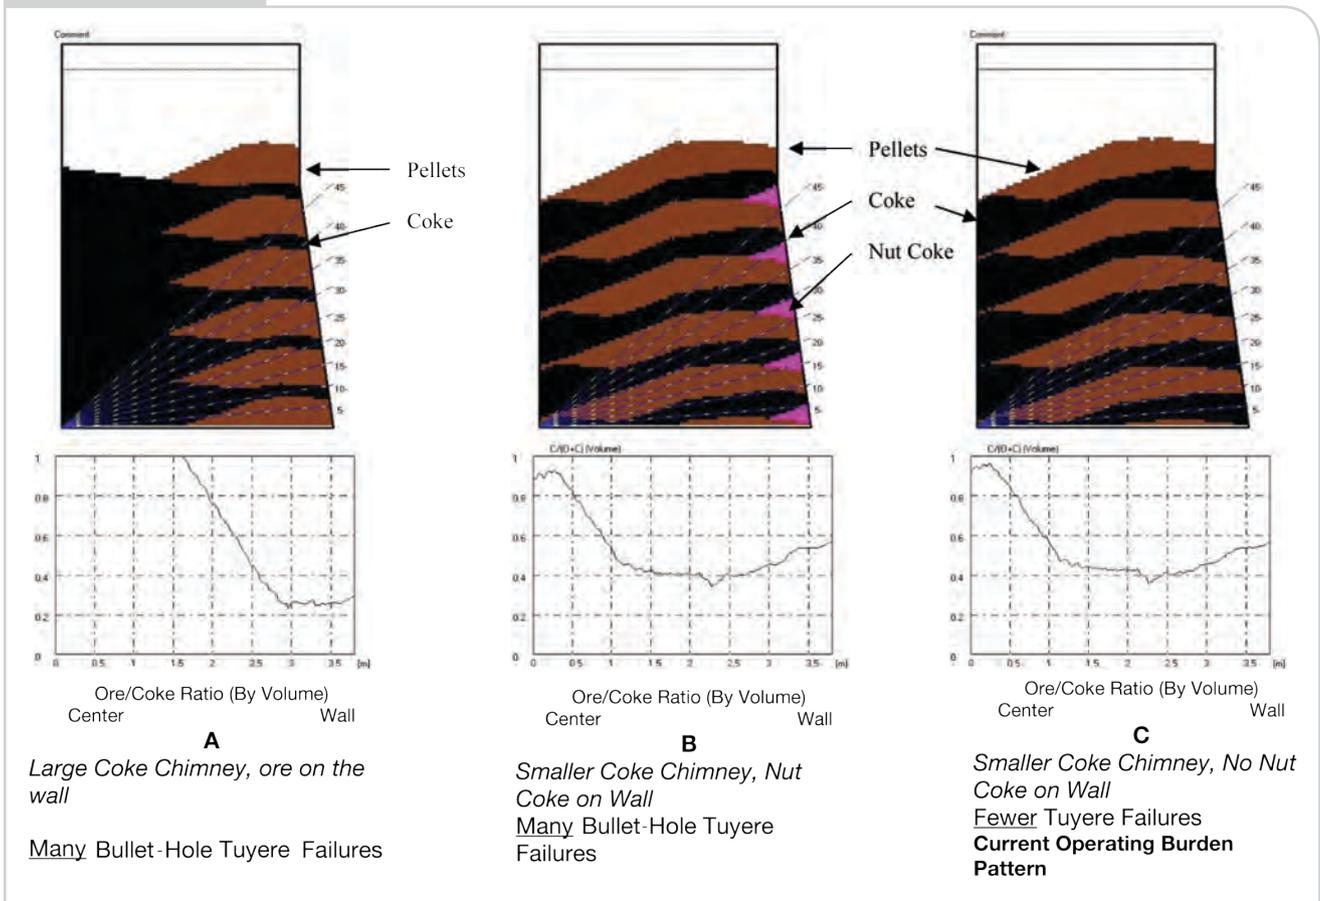
Figure 17

Burden distribution patterns.

Another operating path sought to minimize “short circuits” and “channeling” (events of excessive gas flow on the walls resulting excursions of high top pressure) by increasing the ore loading at the wall, while simultaneously operating with high oxygen levels (targeted blast oxygen up to 34%) to boost productivity. Figure 17a illustrates the high wall ore loading, with Figure 19 showing a two-year raceway adiabatic flame temperature (RAFT) graph. While using this practice, the blast furnace experienced high flame temperatures, (speculated) low cohesive zone position and increased hot metal production at the wall — all variables that increase a tuyeres susceptibility to failure. This operating scheme culminated in an extended outage to replace three tipped tuyeres. The high flame temperature practice was abandoned after repairs were made replacing tipped tuyeres. The target RAFT temperature was reduced 400°F, from 4,100°F, and the ore-to-coke ratio at the wall was increased to 55% from 30% (Figure 17c).

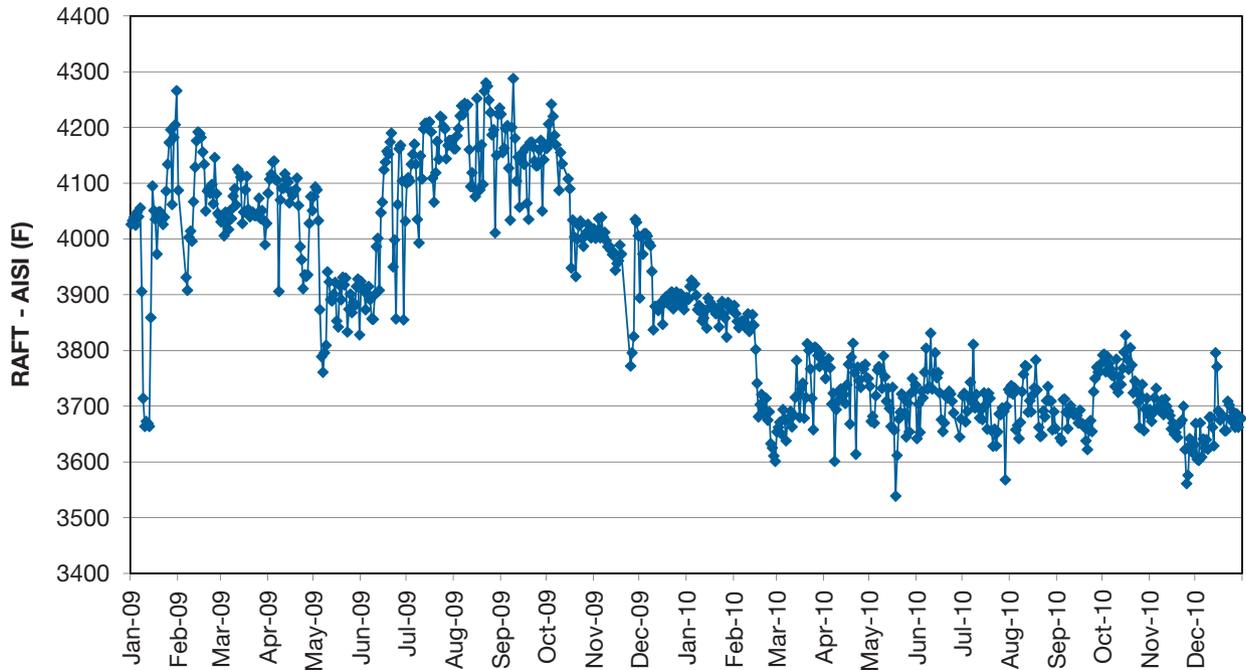
Figure 19

“C” blast furnace RAFT temperature (AISI), January 2009 to December 2010.

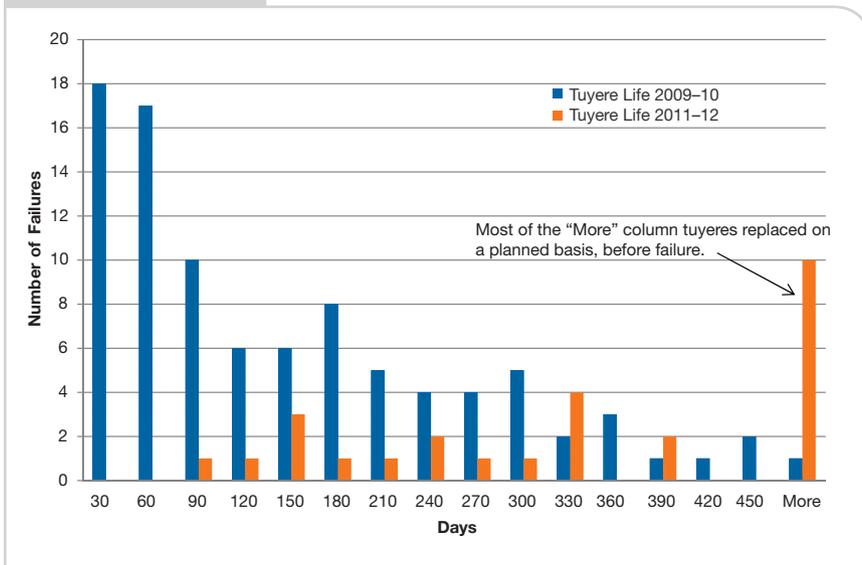
Figure 22

Success of the tuyere reliability project lies in shifting the distribution of failures to the right of the bathtub, eliminating early and mid-life (sudden and complete) failures, and pushing to “degradation failures” (Figure 22). These degradation failures are predictable so tuyere replacement can be managed

Tuyere life graph.

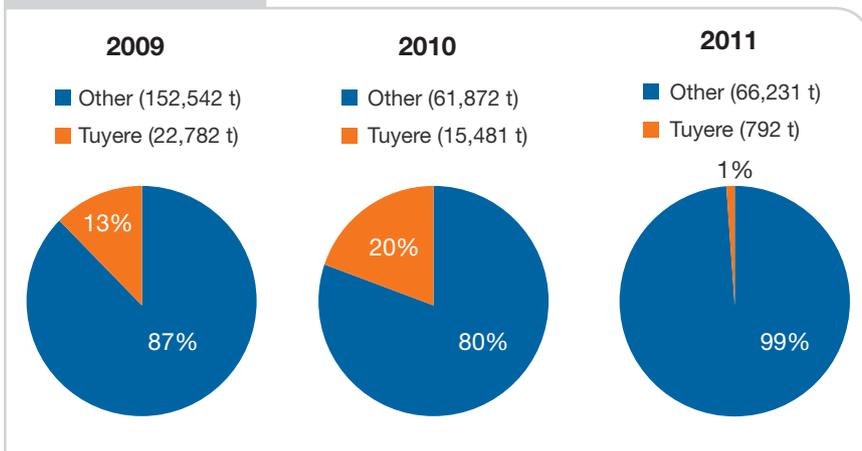
Figure 23

Tonnage lost to tueres failures over a three-year period.
